Fouling comparison of heat exchanger bundles and boiler walls

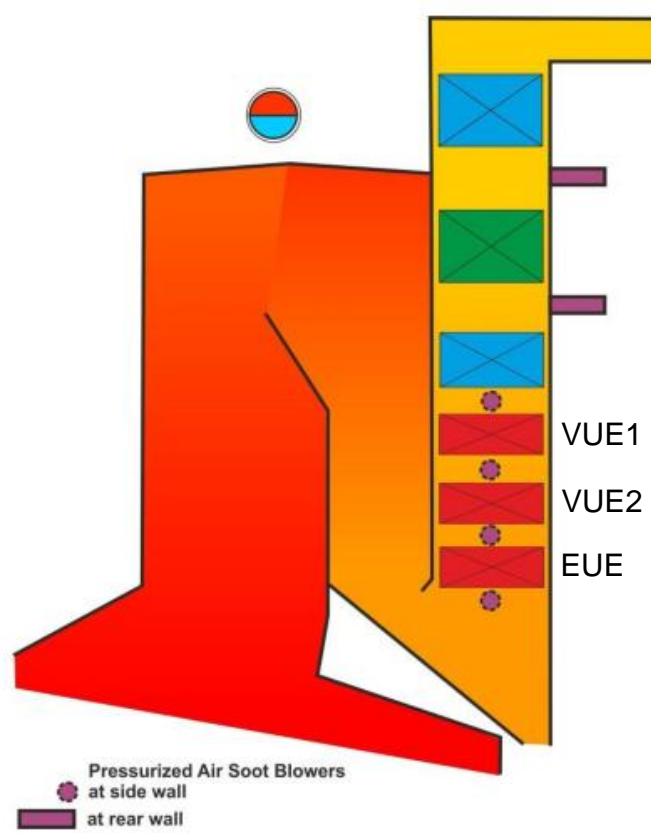
K1 with 6 pressurized air soot blowers	K2 with 2 Shock Pulse Generators
<p>Before 2009: - Cleaning by 6 soot blowers and manual explosion cleanings</p>

<p>Pressurized Air Soot Blowers ■ at side wall ■ at rear wall</p>	<p>From 2009 til 2014 (plant replaced in 2015): -Cleaning by means of 2 EG10 -All sootblowers dismantled -Boiler width: 3.1m</p>

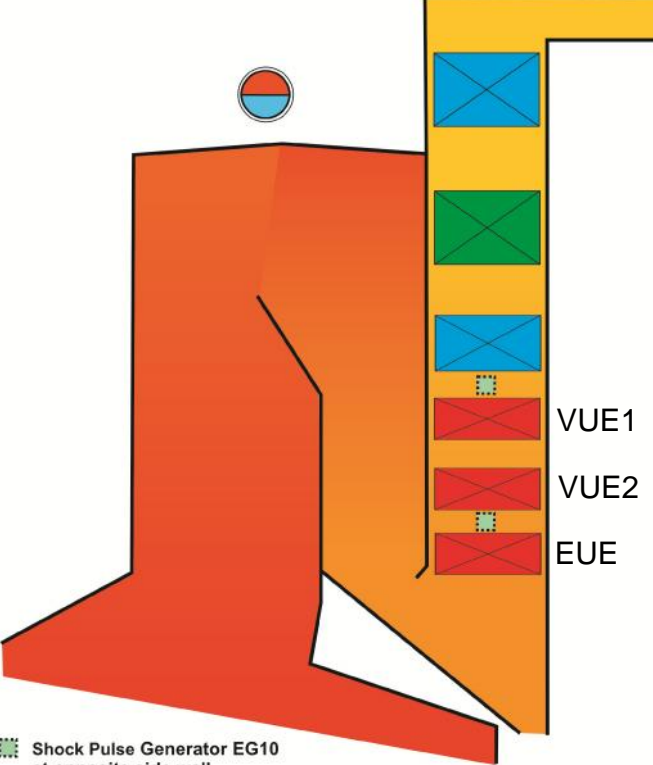
<p>Shock Pulse Generator EG10 ■ at opposite side wall</p>

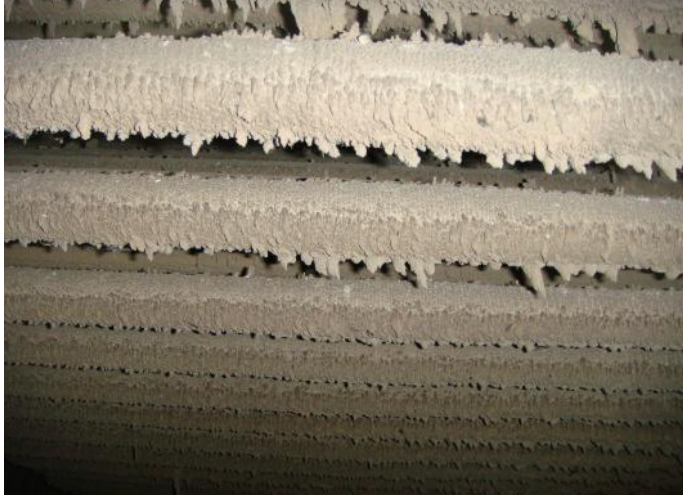
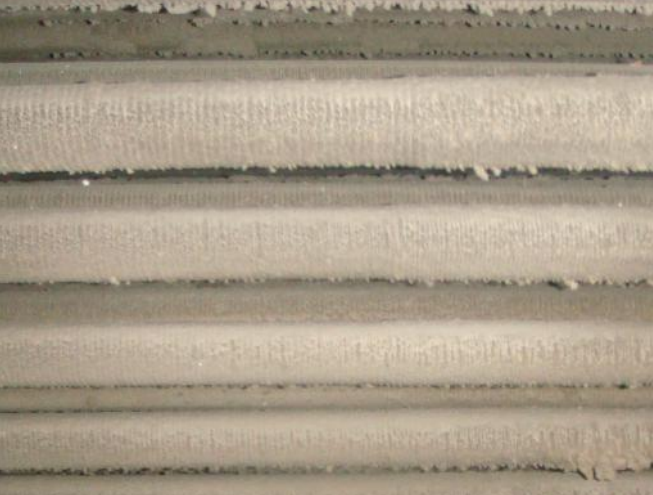
VUE2 (pre-superheater 2), view from below	VUE2 (pre-superheater 2), view from below

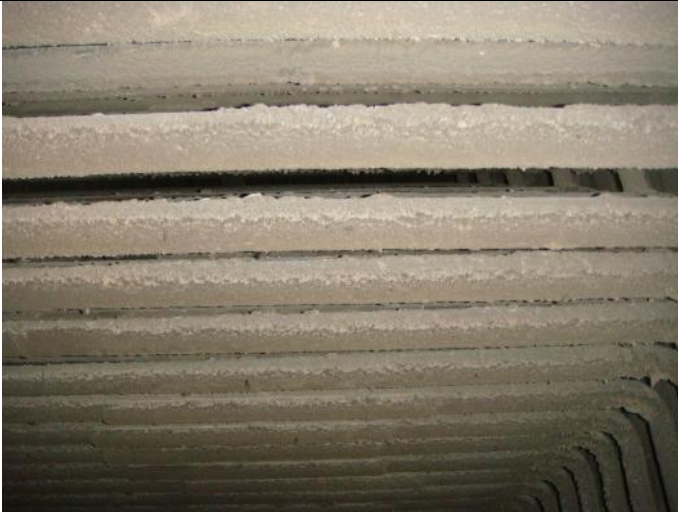
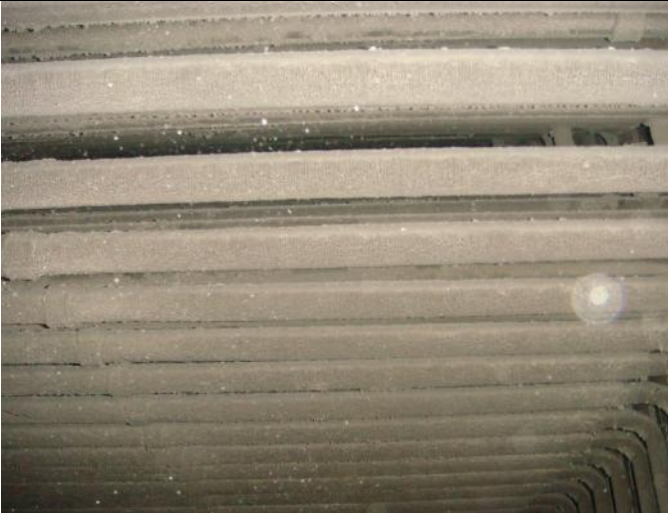
<p>VUE1 (pre-superheater 1), view from below</p>	<p>VUE1 (pre-superheater 1), view from below</p>

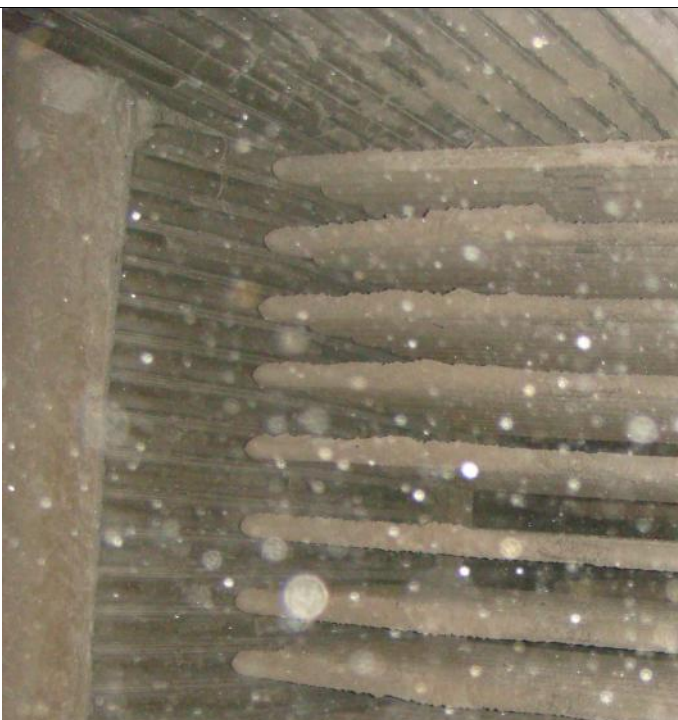
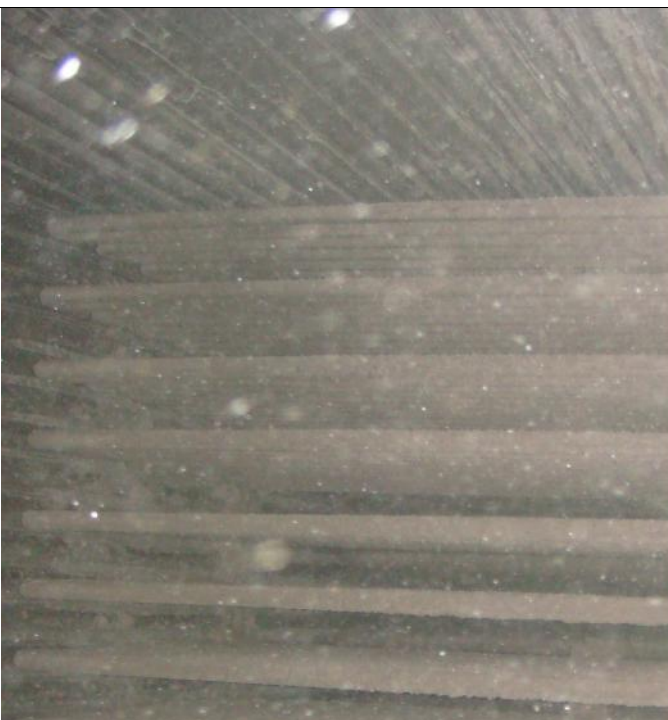
<p>EUE (final superheater), view from below</p>	<p>EUE (final superheater), view from below</p>

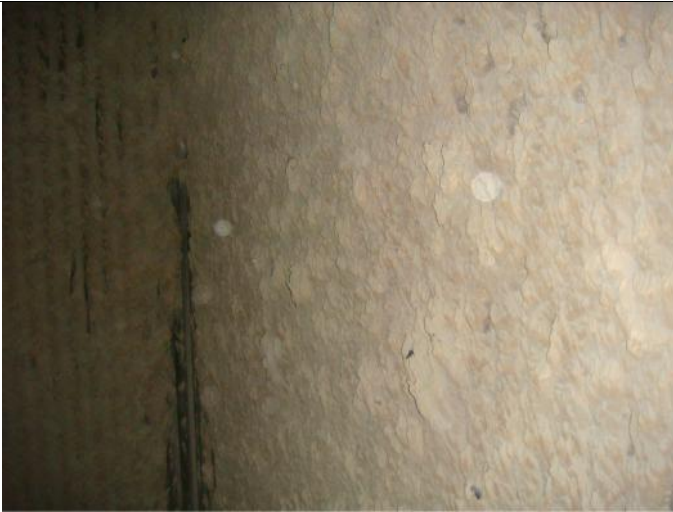
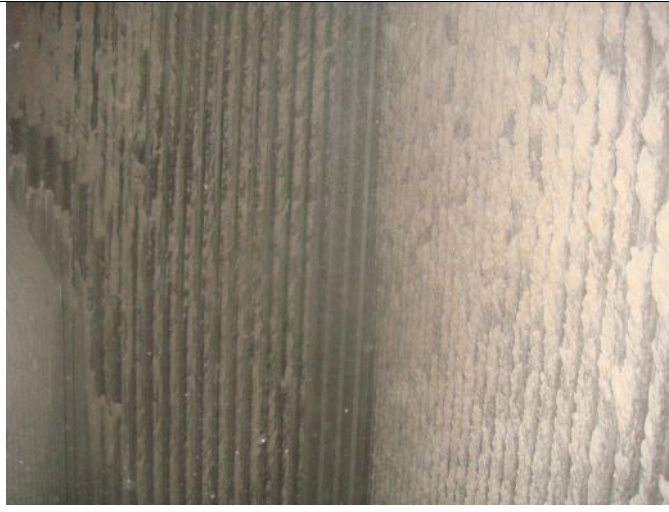
2. pass, RHS boiler wall	2. pass, RHS boiler wall

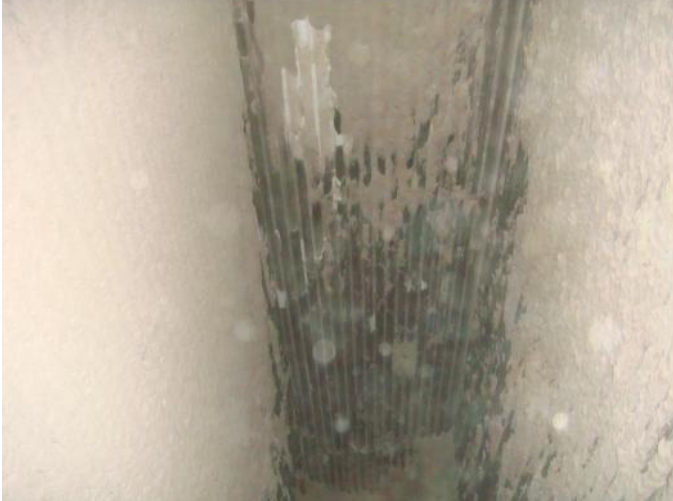
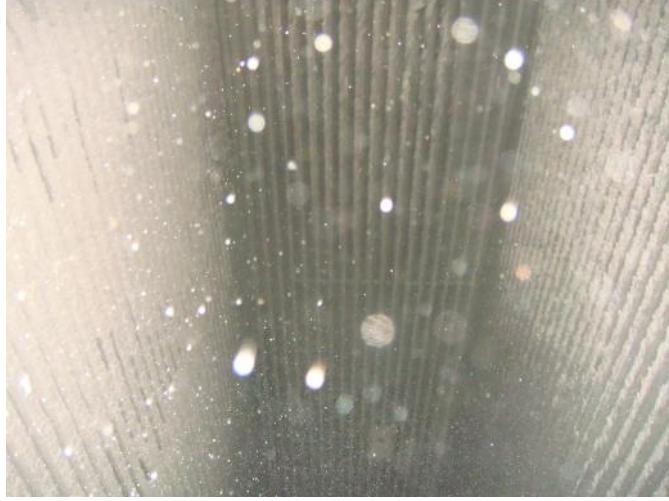
2. pass, rear wall	2. pass, rear wall
